# Manhole Inspection Summary

Manhole # S43E2\_002MH

**Location** Address: **4201 6th St**

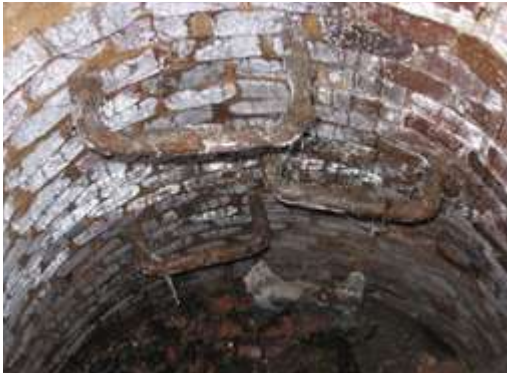
Steps

**Steps** Count: **4** Missing: **0** ☐ Corroded

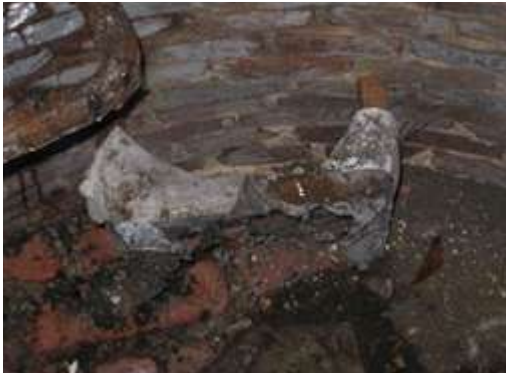
Defect 1

**Surcharge** ☒ **Evidence Of Surcharge** Depth: **6.5** (ft.) ☐ Active Surcharge Present

Surcharge

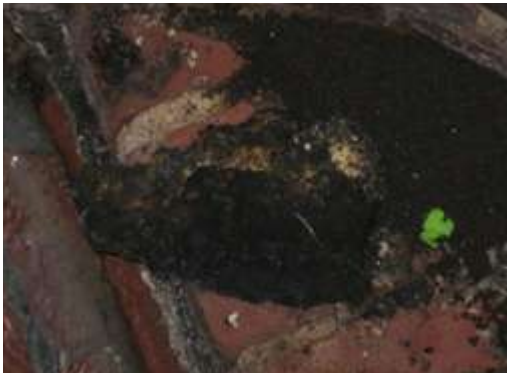
Defect 2

Debris

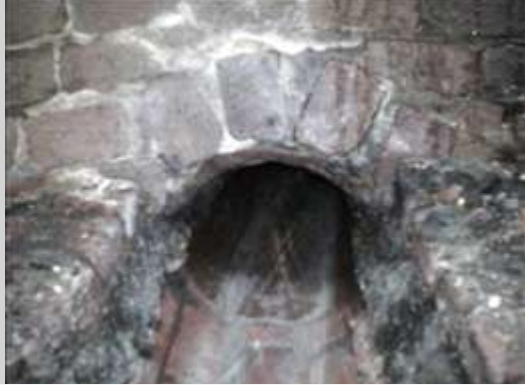
12 O'Clock Outflow

8 in. Circular Gravity Sewer  
Pipe Out @ 12 O'Clock

Pipe Height: **9.6** (in.) Rod and Bar (Angled)  
Pipe Material: **Clay** ☐ Pipe Lined  
Invert Depth: **7.63** (ft.) Flow Characteristics: **Fast**  
Deposits: ☒ None ☐ Mud ☐ Sludge ☐ Debris ☐ Grease  
Silt Depth: (in.) Deposits Extent:  
Infiltration: **None** Pipe Seal Cond: **Sound**

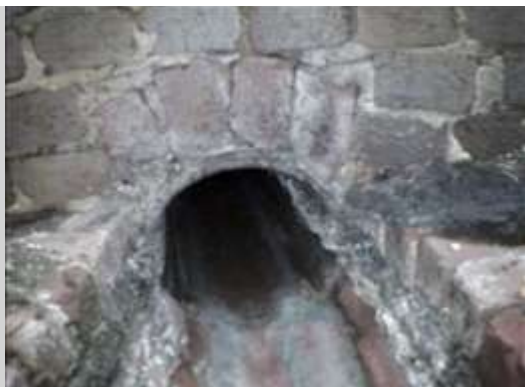
5 O'Clock Inflow

8 in. Circular Gravity Sewer  
Pipe In @ 5 O'Clock

Pipe Height: **9.6** (in.) Rod and Bar (Angled)  
Pipe Material: **Clay** ☐ Pipe Lined  
Invert Depth: **7.56** (ft.) Flow Characteristics: **Fast**  
Deposits: ☒ None ☐ Mud ☐ Sludge ☐ Debris ☐ Grease  
Silt Depth: (in.) Deposits Extent:  
Infiltration: **None** Pipe Seal Cond: **Sound**
